WEAR, FRICTION AND THERMAL FATIGUE OF  
GUN BARREL MATERIALS

Rockwell International Corporation

WEAR, FRICTION AND THERMAL FATIGUE  
OF GUN BARREL MATERIALS  
FINAL REPORT

Department of the Army  
U.S. Army Weapons Command  
Watervliet Arsenal  
Watervliet, New York 12189

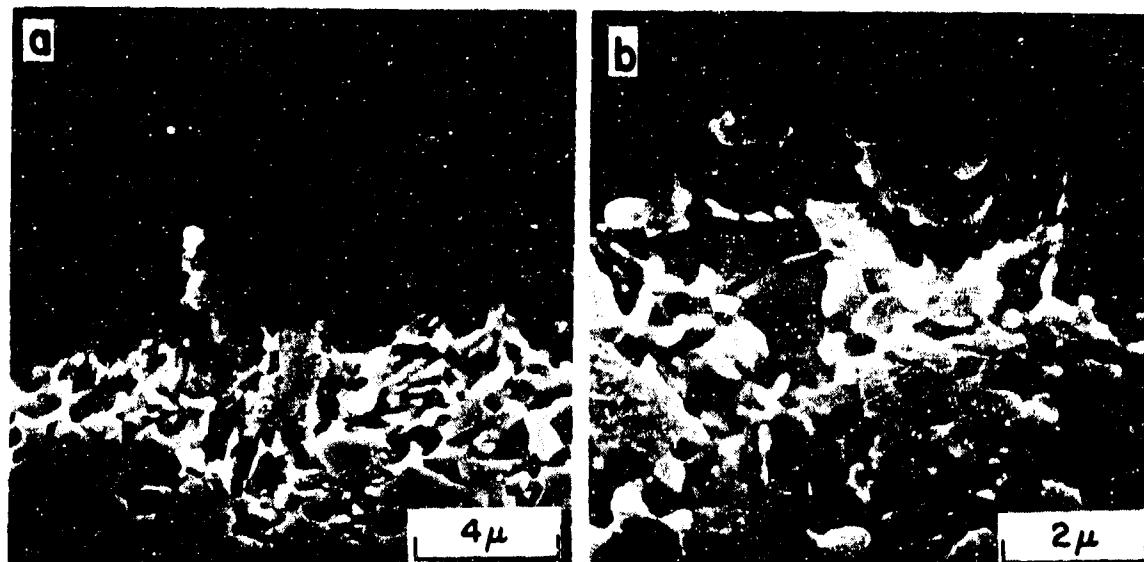
Fig. 36 Scanning electron micrograph of electropolished section of specimen BH showing crack blunting at Cr/steel interface. Cr on top.
